TEST REPORT

No. : TJN1802002236ML
 Date : Mar 07, 2018
 Page : 1 of 5

Sample Name : Swivel Coupler
 Product Specification : QD48.3*OD48.3mm
 Manufacturer : Tianjin Wellmade Scaffold Co., Ltd

1. Test Item: Slipping force, Failure force and Indentation

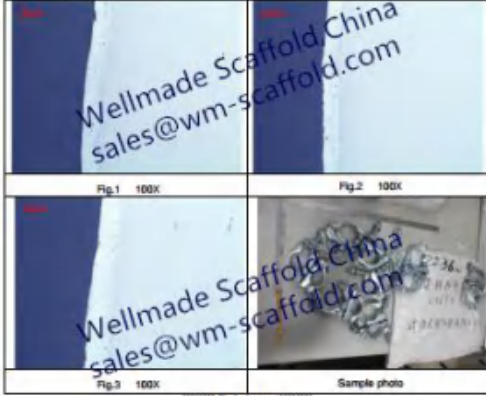
Sample No.	Result (μm)					Conc.	Note
	1	2	3	4	5		
1	76.7	74.3	66.7	57.8	71.1	+15	Pass Fig.1
2	67.2	66.8	66.1	69.5	66.1	+15	Pass Fig.2
3	82.3	101.0	104.3	104.3	99.2	+15	Pass Fig.3
